NOTICE TO MARINERS

Issue date: 18/01/2022

1. Demarcation Buoy 9 Special mark unlit

8460001-PC0010-MWE-0059

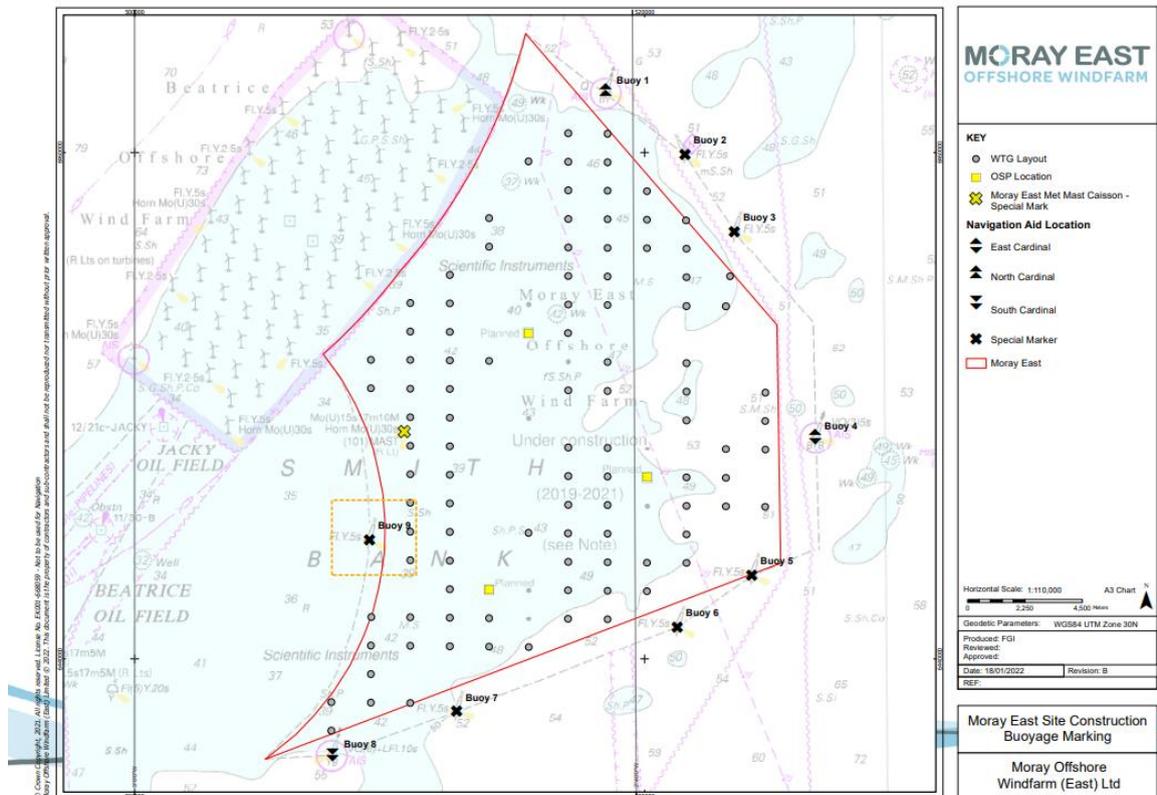
Figure 1 – Demarcation Buoy locations

Please be advised that Moray Offshore Windfarm (East) Limited (Moray East) are reporting that Buoy 9 Special Mark has been reported as unlit

Please be aware that while navigating the area to keep an extra look out for the unlit buoy 9 (Special marker buoy) during the hours of darkness and reduced visibility, until such a time as the buoy is repaired.
