moray offshore renewables ltd

Environmental Statement

Technical Appendix 5.2 E - Navigational Risk Assessment (OfTI)

Telford, Stevenson, MacColl Wind Farms
and associated Transmission Infrastructure
Environmental Statement

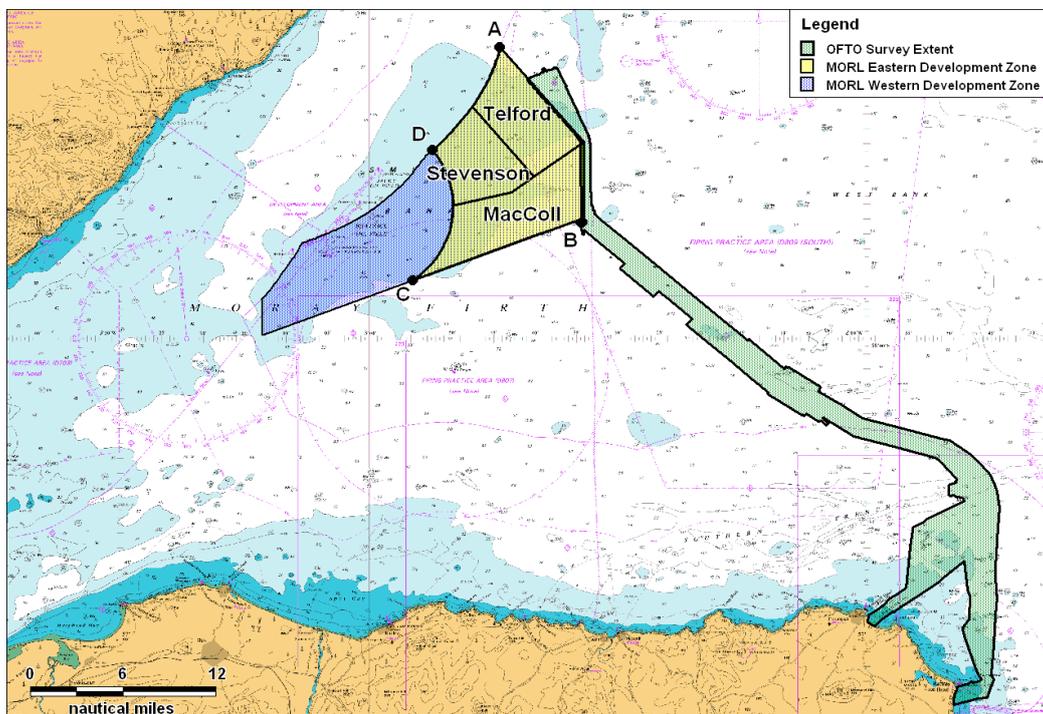
Figure 2.1 Chart Overview of EDA and Cable Route

A chart of the site boundary and corner points is presented in Figure 2.1.

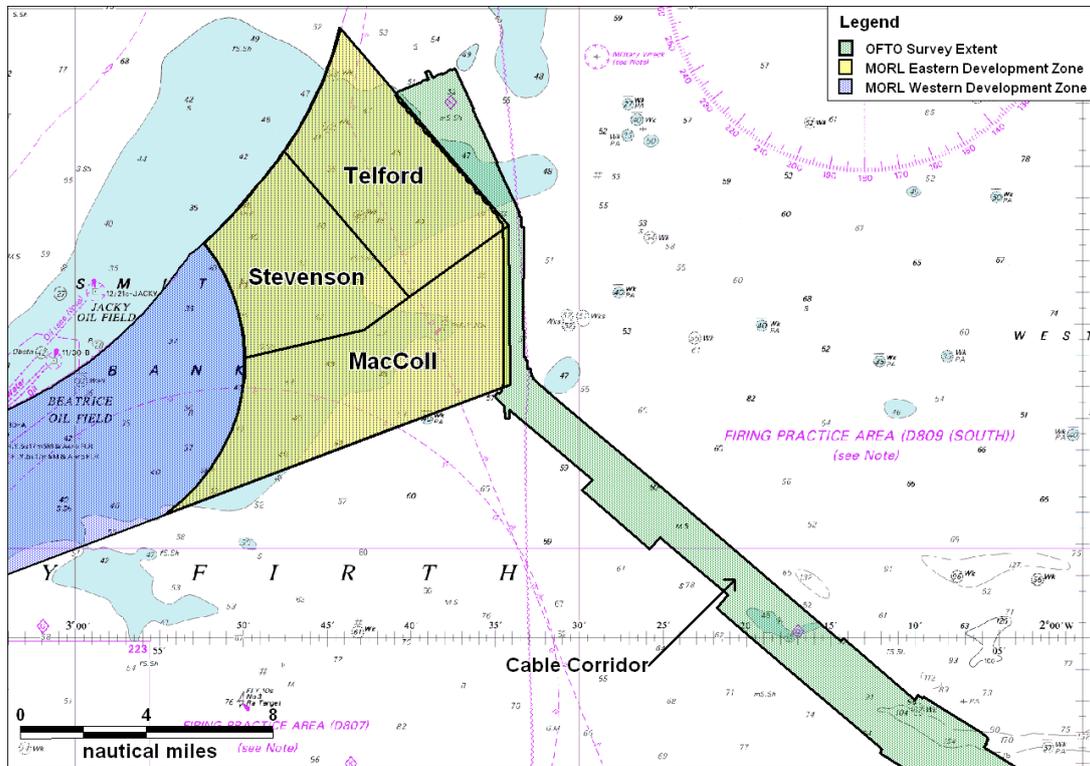
Figure 2.2 Detailed Chart of the Northern Section of the Cable Route

A detailed plot of the northern section of the offshore export cable route corridor is presented in Figure 2.2. It is noted that both the Fraserburgh Bay and Peterhead options follow the same route on the northern section of the export cable route.

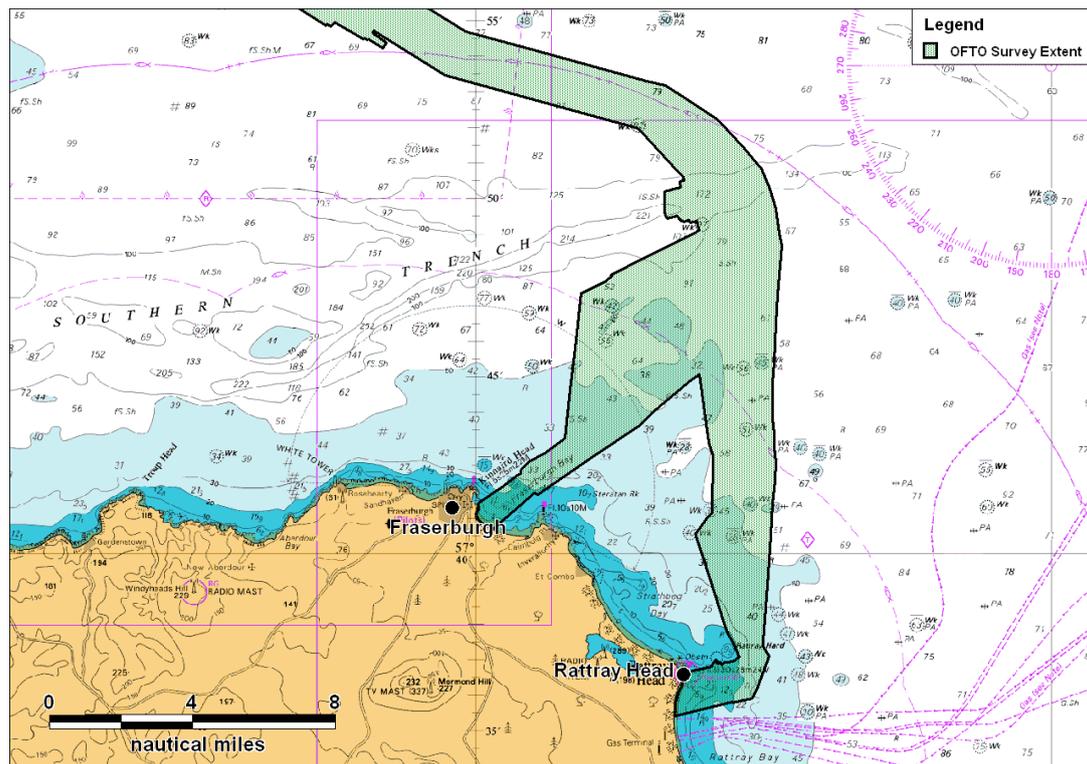
Figure 2.3 Detailed Southern Cable Route and Landfall

Figure 2.3 presents a detailed chart of the southern section of the cable route and landfall options.

The offshore export cable route runs for approximately 46nm south and east from the three proposed wind farms, where the cable route has two landfall options.

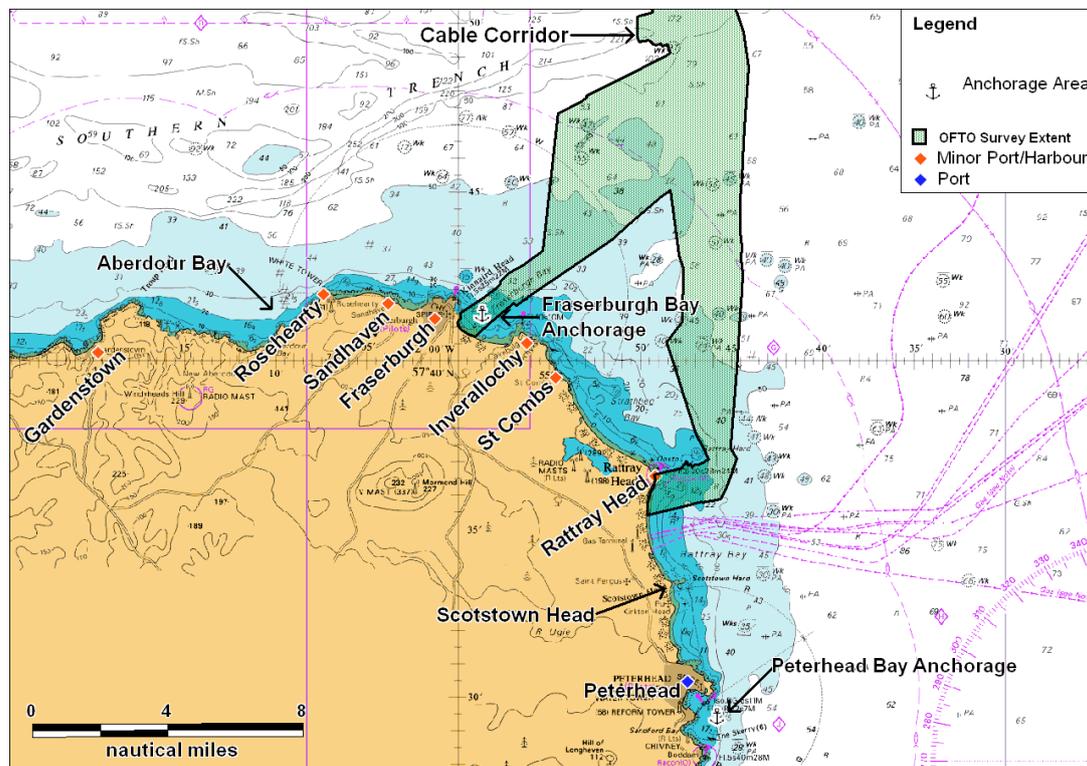
Figure 3.1 Detailed Plot of Moray Firth Ports and Harbours

A chart of nearby ports, harbours and anchorage areas relative to the cable route extracted from the Admiralty Sailing Directions for the area (Ref. i) is presented in Figure 3.1.

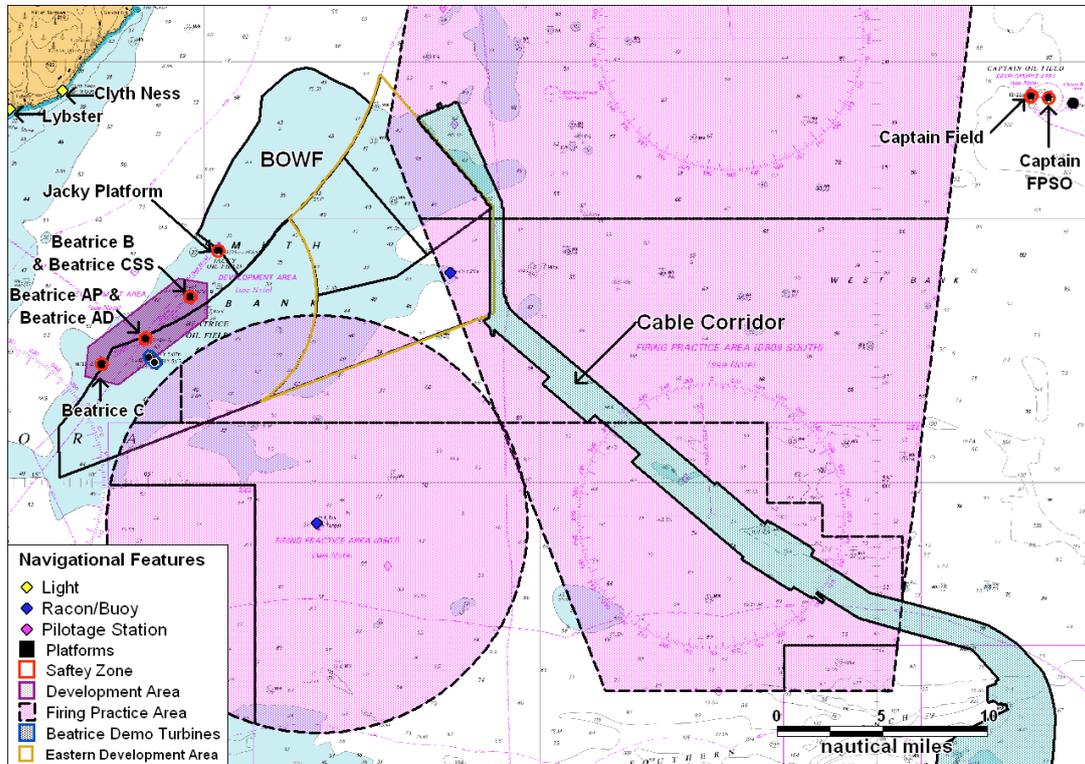
Figure 3.2 Navigational Features relative to the Cable Route (Northern Corridor)

A plot of the navigational features relative to the northern and southern (landfall) sections of the export cable routes is presented in Figure 3.2 and Figure 3.3.

The main navigational features relative to the offshore export cable route is the Firing Practice Area D809 (South) which the cable route intersects for approximately 34nm.

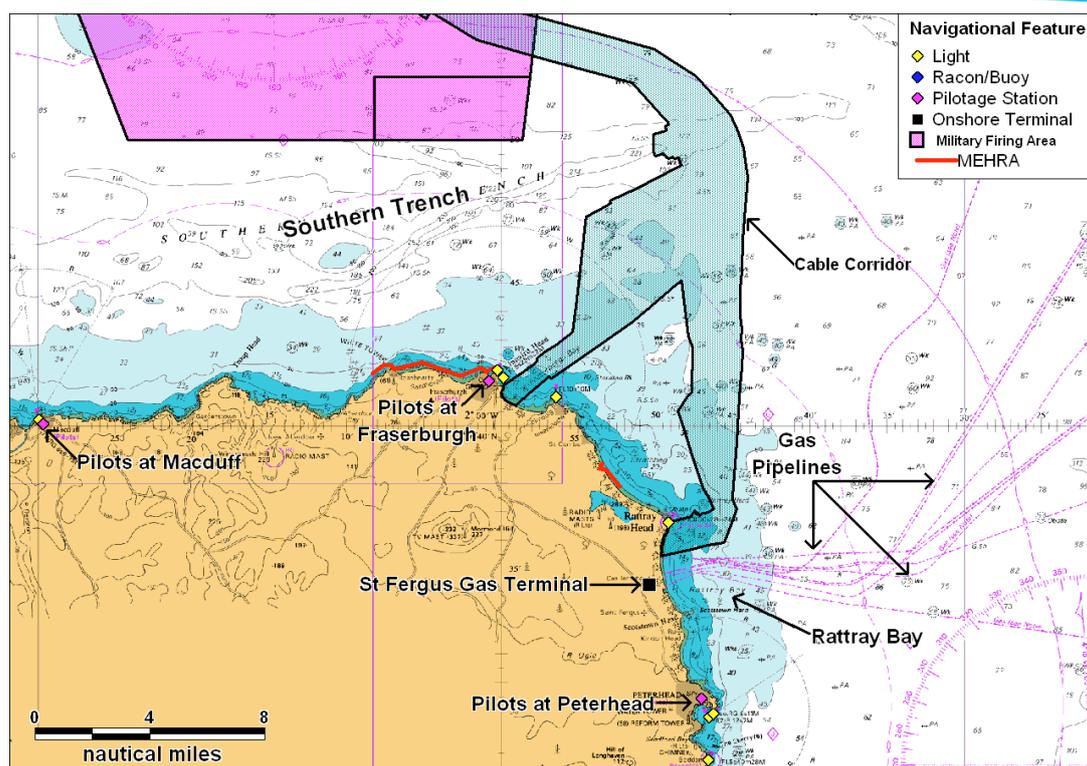
Figure 3.3 Navigational Features relative to the Cable Route (Southern Corridor)

The main navigational features relate to the two landfall options relate to two main harbours/ports in the area. The Fraserburgh Bay landfall option is located less than 1km from the harbours South Breakwater. The Rattray Head landfall option is located less than 1km north of a number of gas pipelines in Rattray Bay that run from various North Sea offshore platforms to the onshore St Fergus Gas Terminal. A chart extract for the area states:

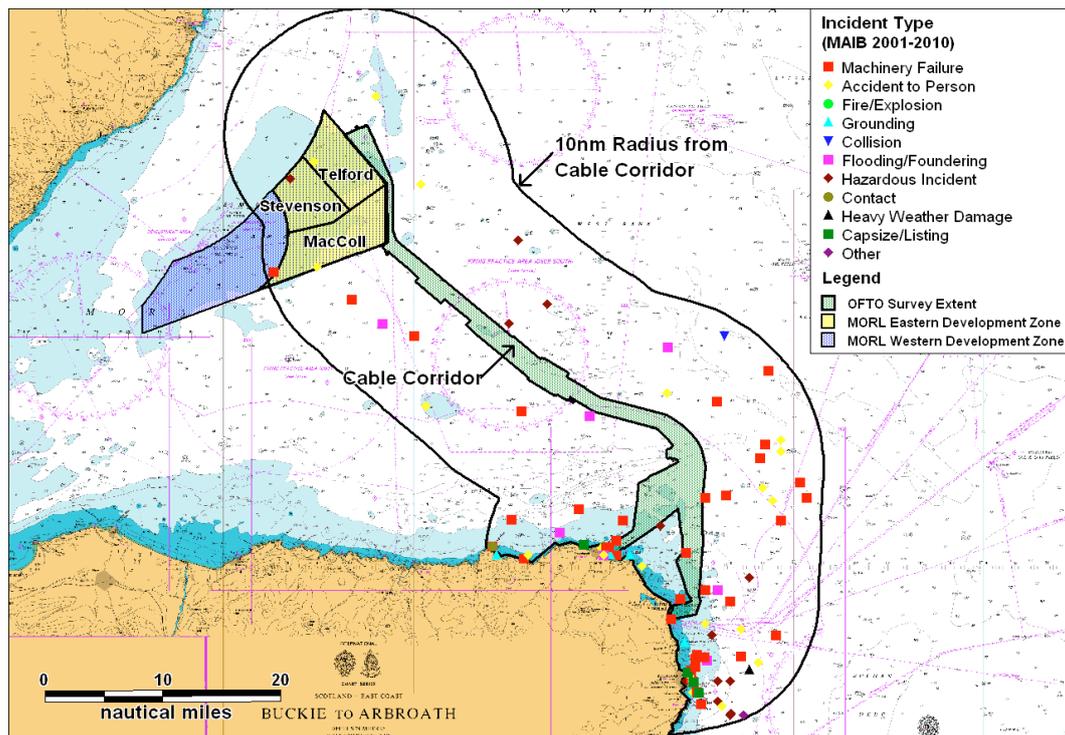
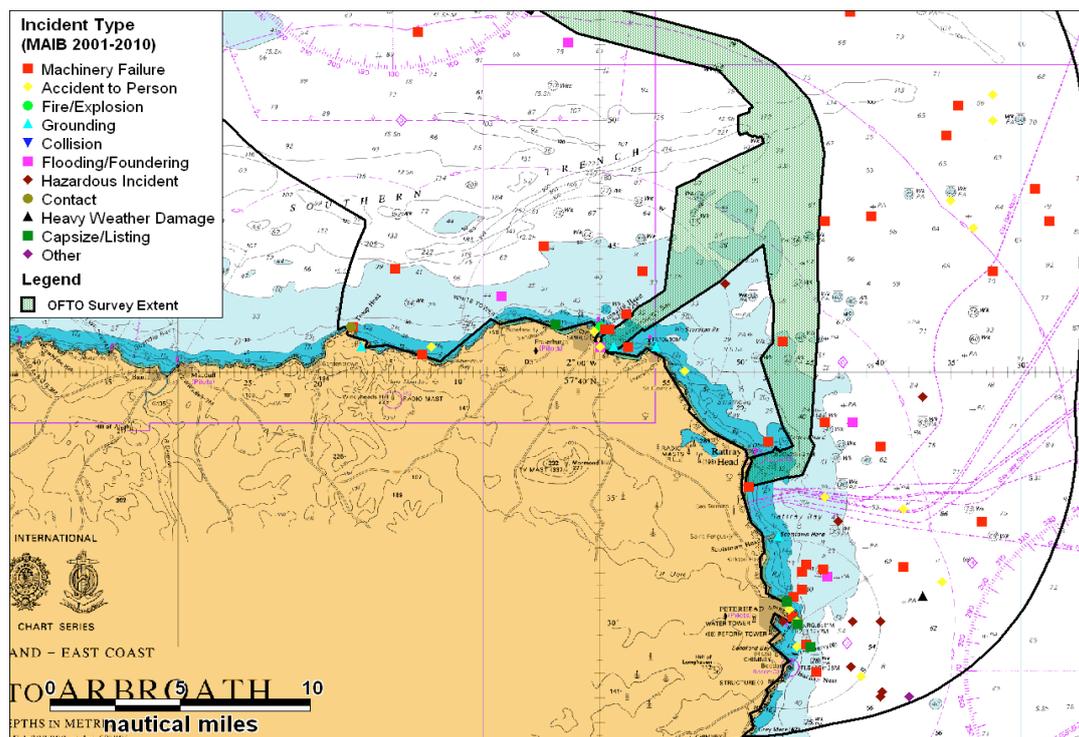
The locations¹ of accidents, injuries and hazardous incidents reported to MAIB within 10nm of the offshore exportEDA cable route between January 2001 and December 2010 are presented in Figure 4.1 and Figure 4.2, colour-coded by type.

Figure 4.1 MAIB Incident Locations by Type within 10nm of Cable Route

Figure 4.2 Detailed MAIB Incident Locations off Landfall Options by Type within 10nm of the Cable Route

A total of 137 incidents were reported within 10nm of the cable route, corresponding to an average of 14 per year. The majority of the incidents occurred in the coastal area between Fraserburgh Bay and Peterhead Bay. The distribution by incident type is presented in Figure 4.3.

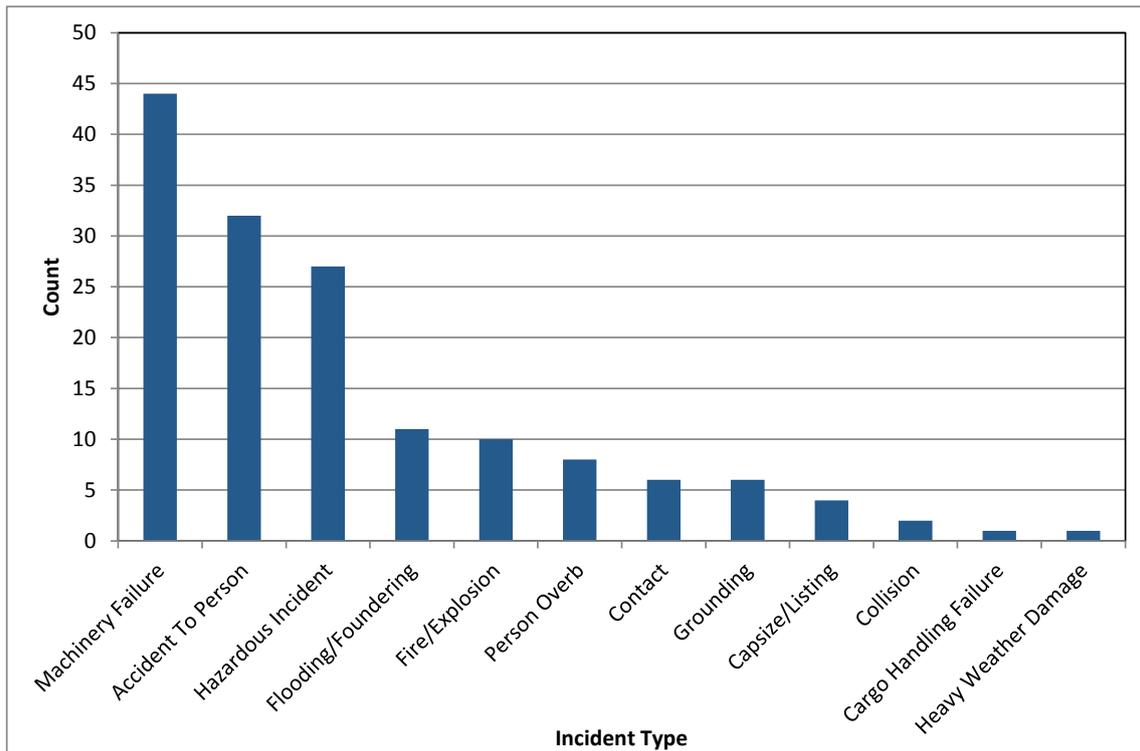
Figure 4.3 MAIB Incidents by Type within 10nm of the Cable Route (2001-2010)

The most common incident type recorded within 10nm of the offshore export cable route was machinery failure, representing 29% of all incidents over the ten year period.

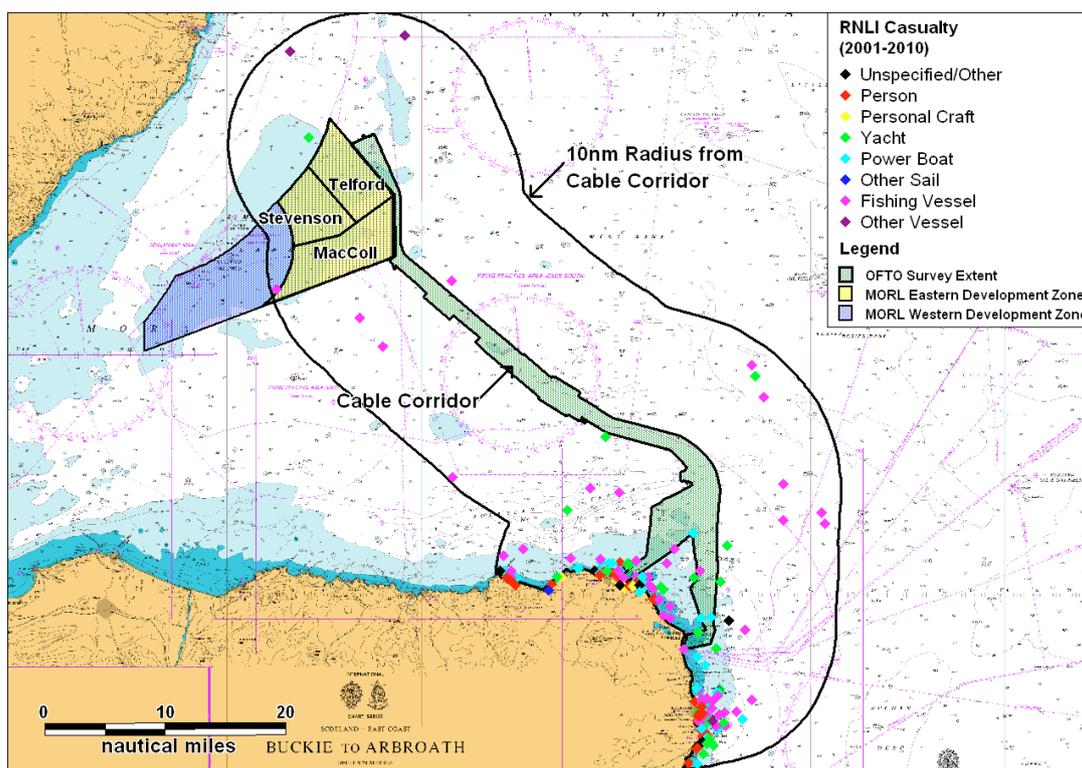
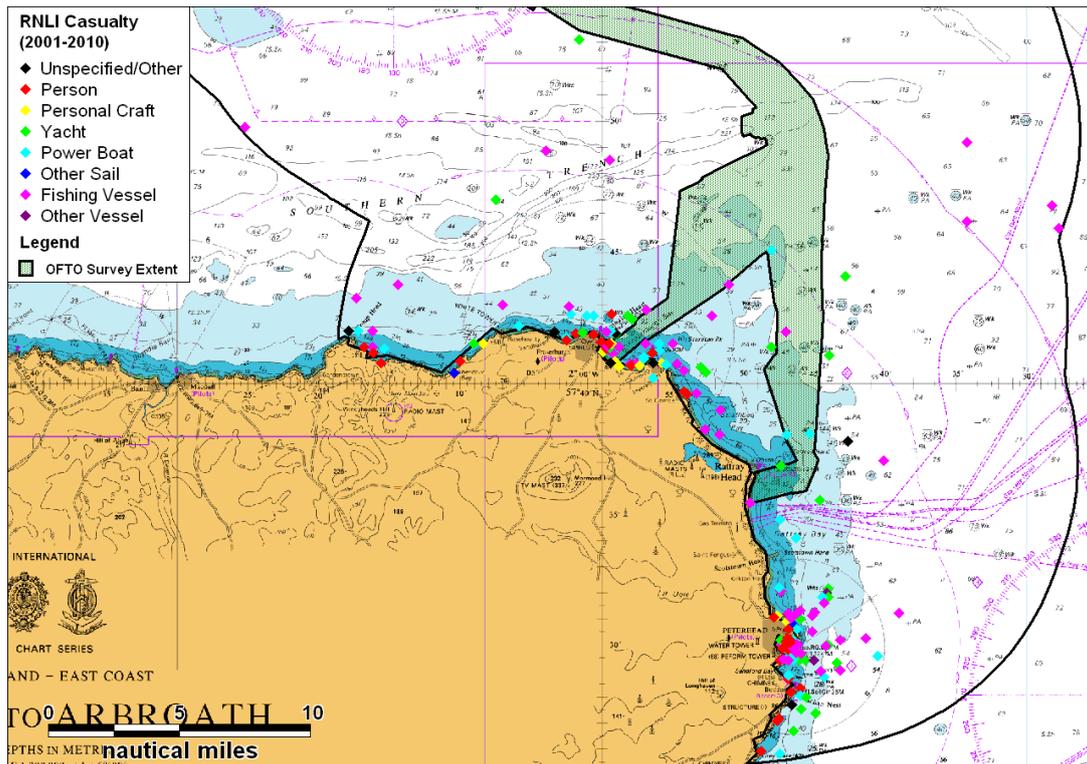
Figure 4.4 and Figure 4.5, present overview and detailed plots of the geographical location of incidents colour-coded by casualty type. It can be seen that the vast majority occurred near the coast (off Fraserburgh and Peterhead Bay), with relatively few further out to sea.

Figure 4.4 Overview RNLI Incidents by Casualty Type within 10nm of the Cable Route

Figure 4.5 Detailed RNLi Incidents by Casualty Type for Landfall Options

Four incidents were recorded within the offshore export cable route over the 10 year period analysed, three machinery failures on recreational power boats and a machinery failure on a large fishing vessel 5.3nm north of Rattray Head.

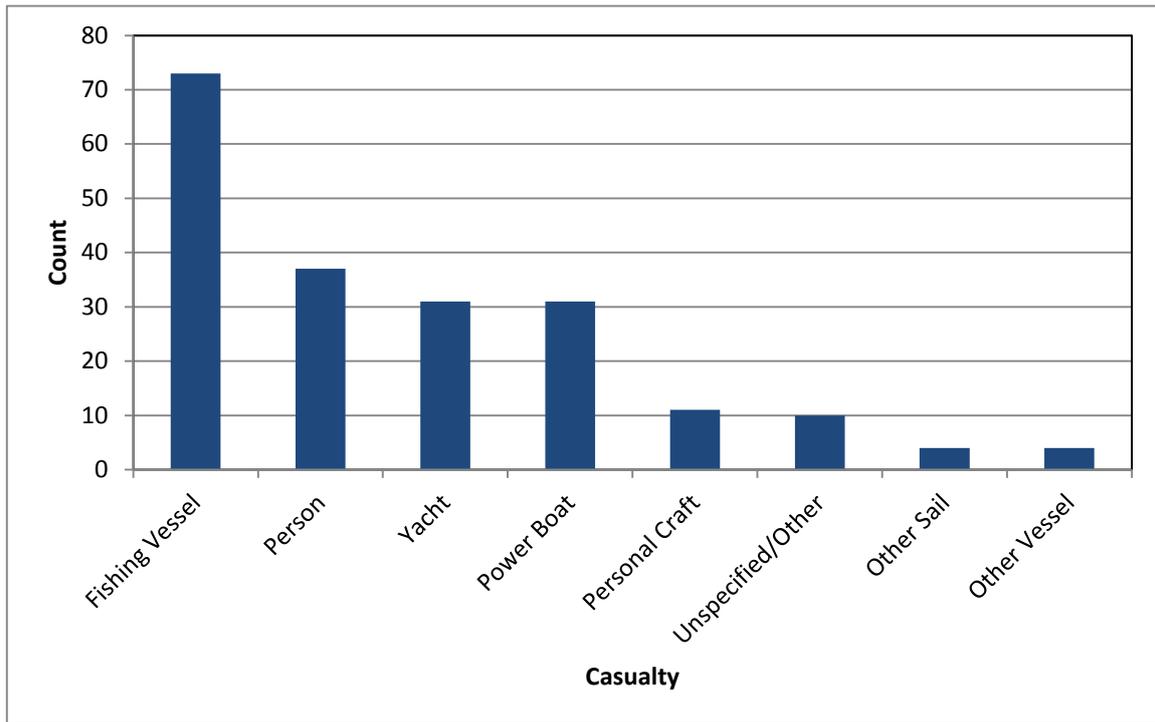
Figure 4.6 RNLi Incidents by Casualty Type within 10nm of the Cable Route (2001-2010)

Fishing (36%), person (18%) and yacht (15%) were the most common casualty types involved. The remainder of casualties were generally made up of inshore vessels, i.e. power boats (15%) and personal craft/canoes (5%).

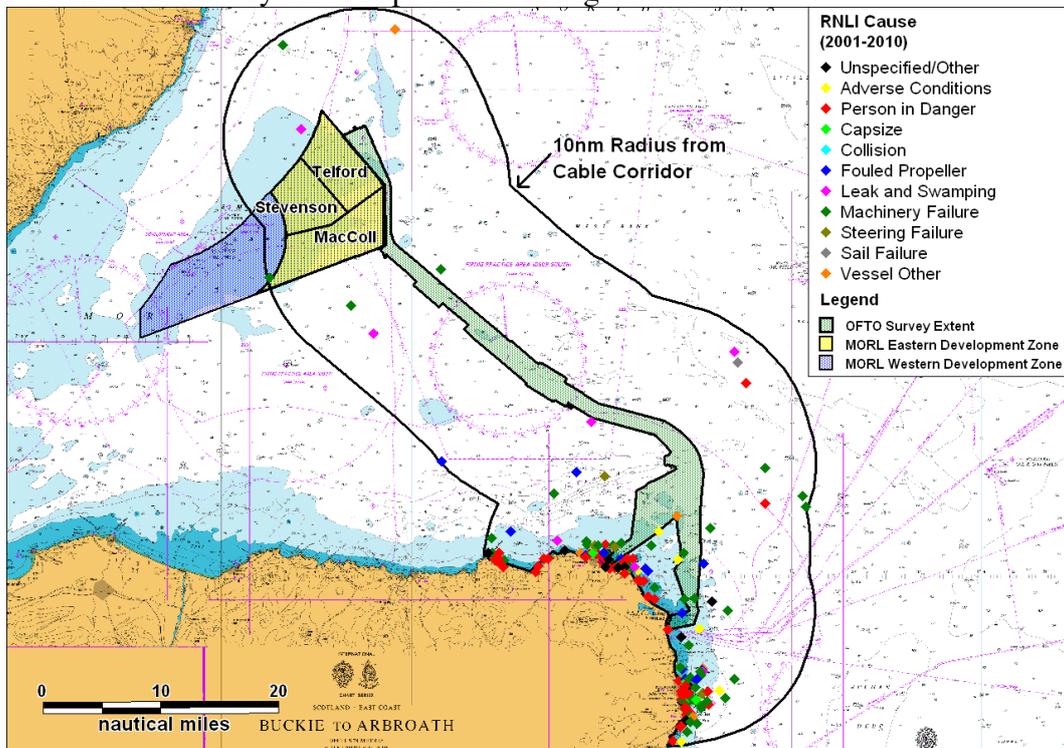
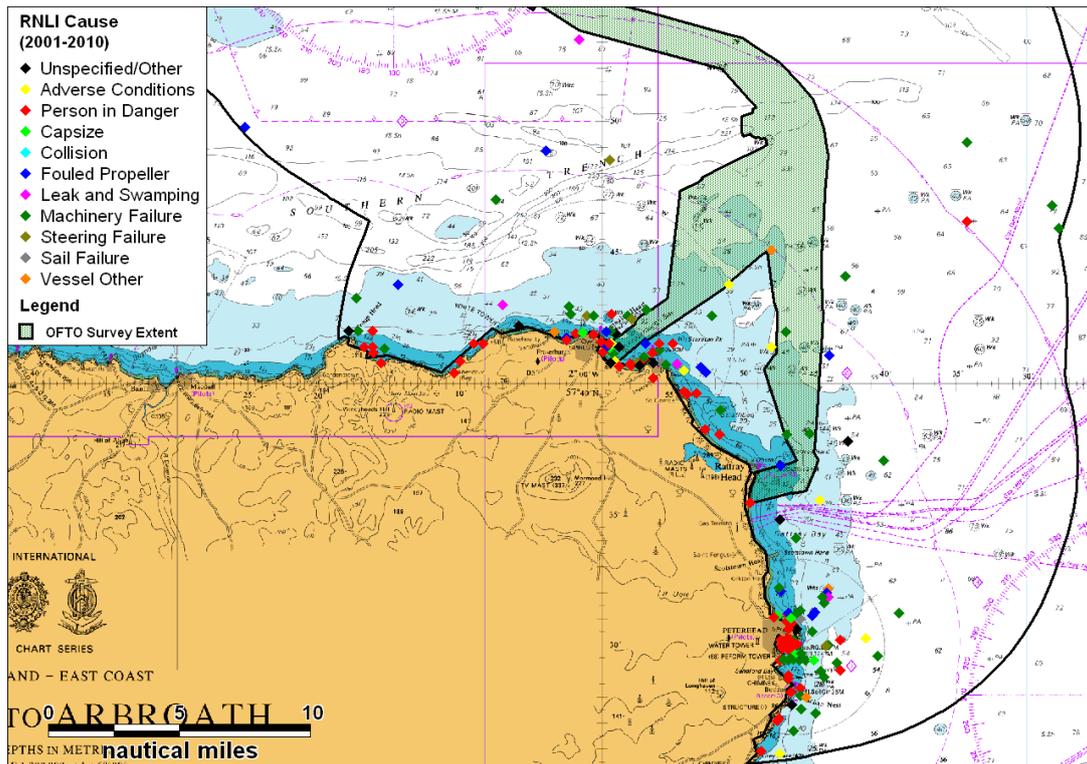
A chart of the incidents by cause is presented in Figure 4.7.

Figure 4.7 Overview RNLi Incidents by Cause within 10nm of the Cable Route

Figure 4.8 Detailed RNLi Incidents by Cause for Landfall Options

The main reported causes were person in danger (36%) and machinery failure (28%).

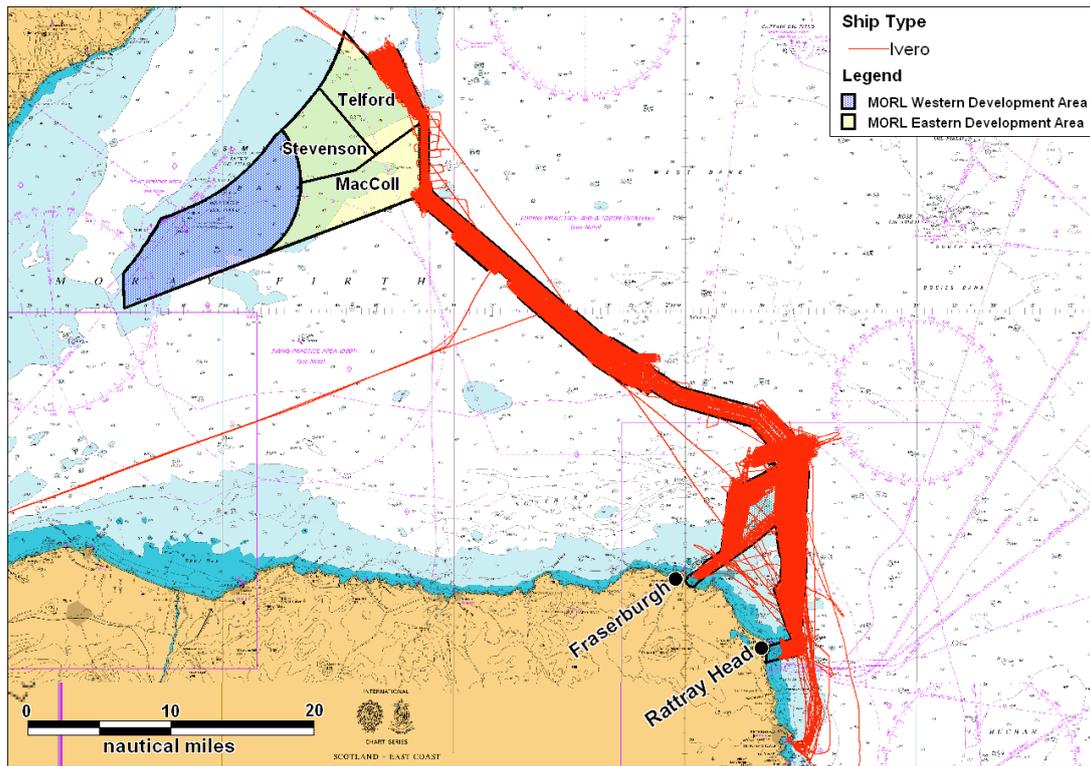
Figure 5.2 Ivero Survey Vessel Positions 6th July to 2nd October 2011

Tracks of the *Ivero* vessel recorded on AIS during survey operations in the cable corridor are presented in Figure 5.2.

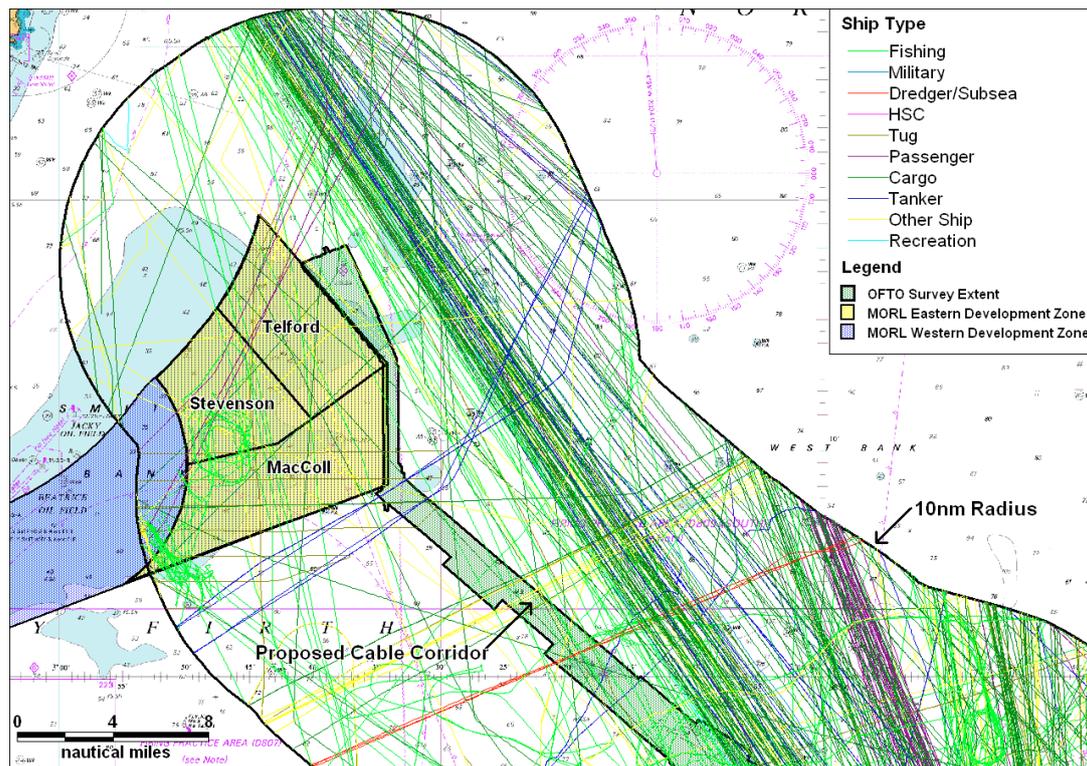
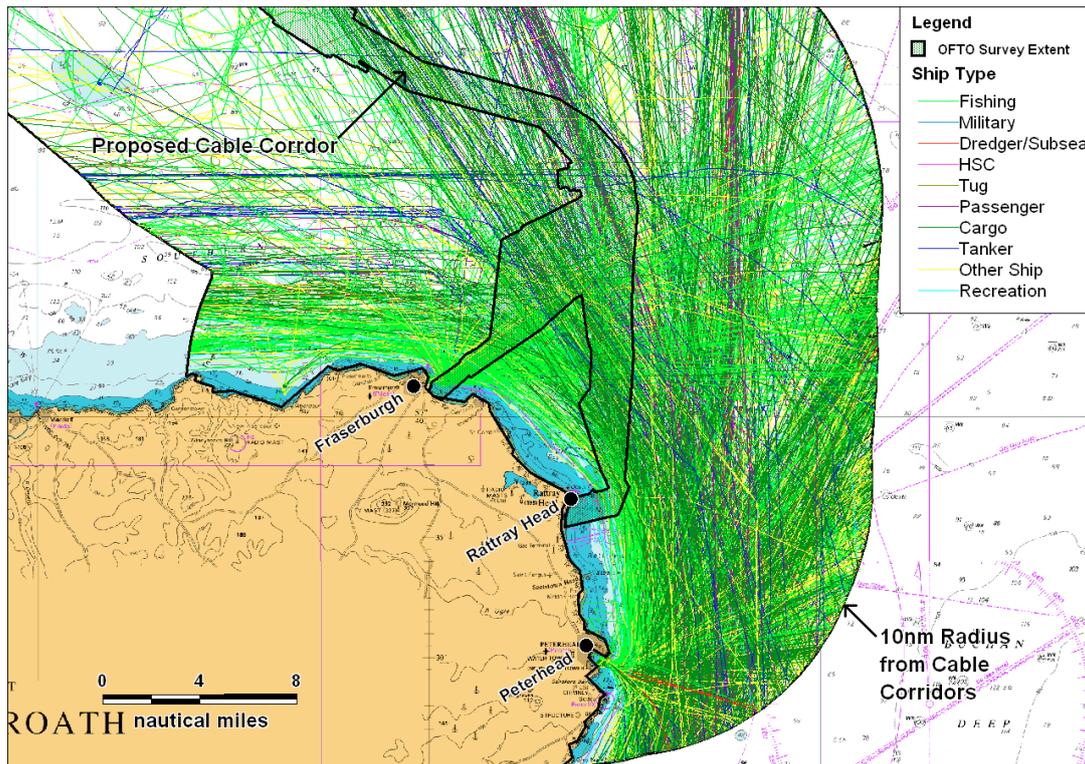
Charts of the vessels recorded on AIS from 26th August to 22nd September 2011, colour-coded by ship type, are presented in Figure 5.3 and Figure 5.4.

Figure 5.3 Ivero Survey Northern Section of the Cable Route (28 Days AIS tracks)

Figure 5.4 Ivero Survey Southern Section of Cable Route (28 Days AIS tracks)

As can be observed from the shipping plots, the majority of vessel tracks were fishing vessels headed to/from fishing grounds to land fish in Fraserburgh and Peterhead. In addition, vessels were recorded heading north/south off the Aberdeenshire coast, including the North Link ferry route to the Northern Isle (from Aberdeen). Shipping also passes north by north west / south by south east from Rattray Head to Pentland Firth.

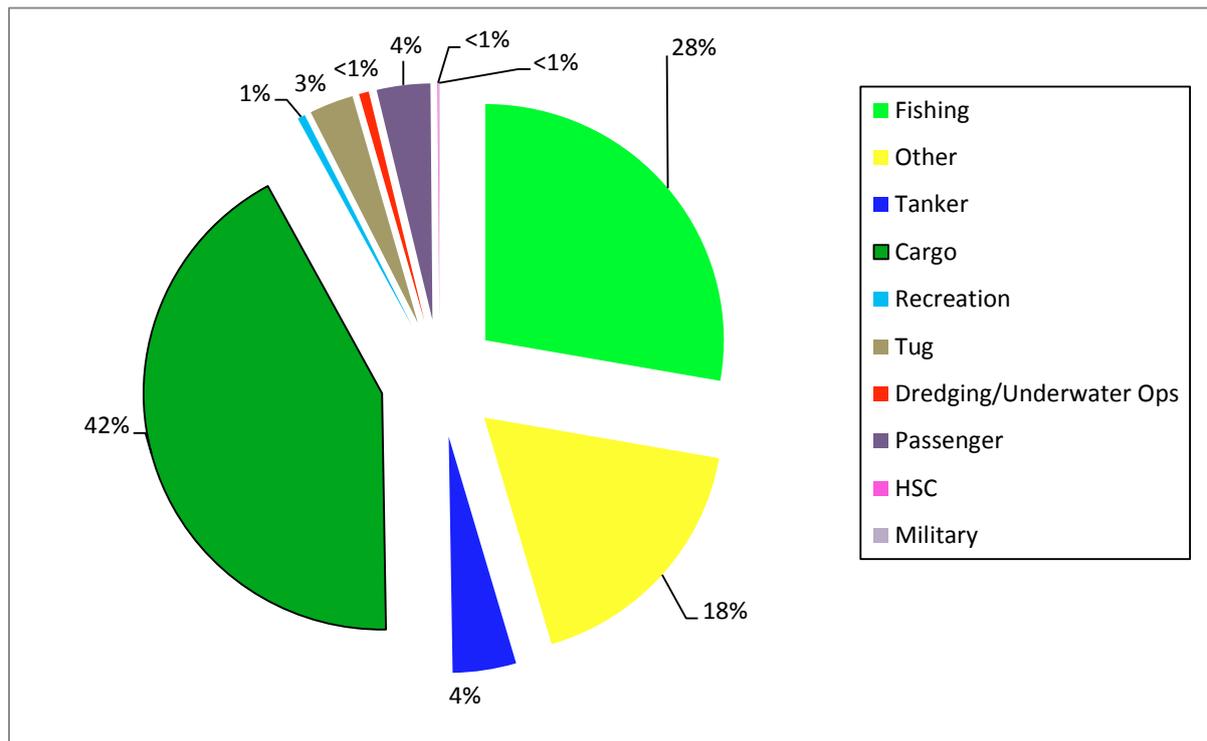
Figure 5.5 Vessel Types identified during the Survey (28 days)

The breakdown of ships by type for vessels within 10nm of offshore export cable route is presented in Figure 5.5. This considers all vessels recorded during the 28 day period.

The most common vessel type recorded during the 28 day survey were cargo ships (42%), fishing vessels (28%) and other vessels contributing (18%).

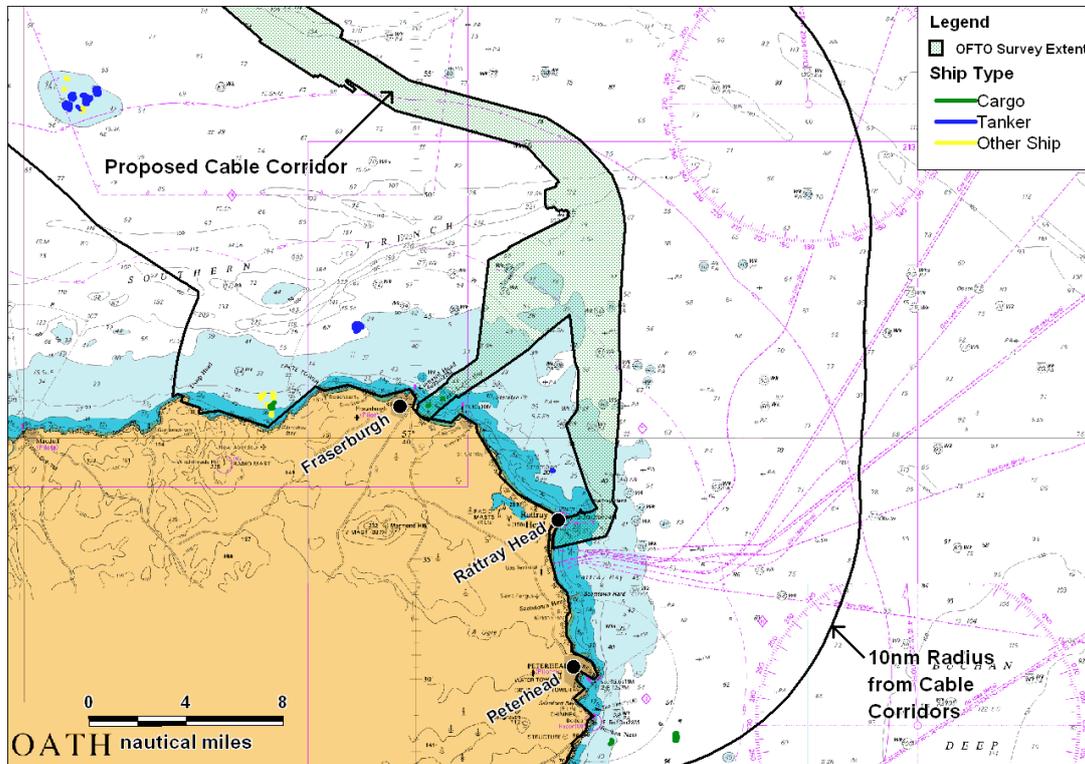
Figure 5.6 Anchored Vessels during Survey July to October 2011 (84 Days)

The positions of vessels at anchor within 10nm of the offshore export cable route recorded during the combined survey period, 6th July to 2nd October 2011 (84 days) are presented in Figure 5.6.

Five vessels were recorded at anchor within Aberdour Bay 7.3nm west of the Fraserburgh cable route. These vessels were composed of four offshore supply vessels and one general cargo vessel.

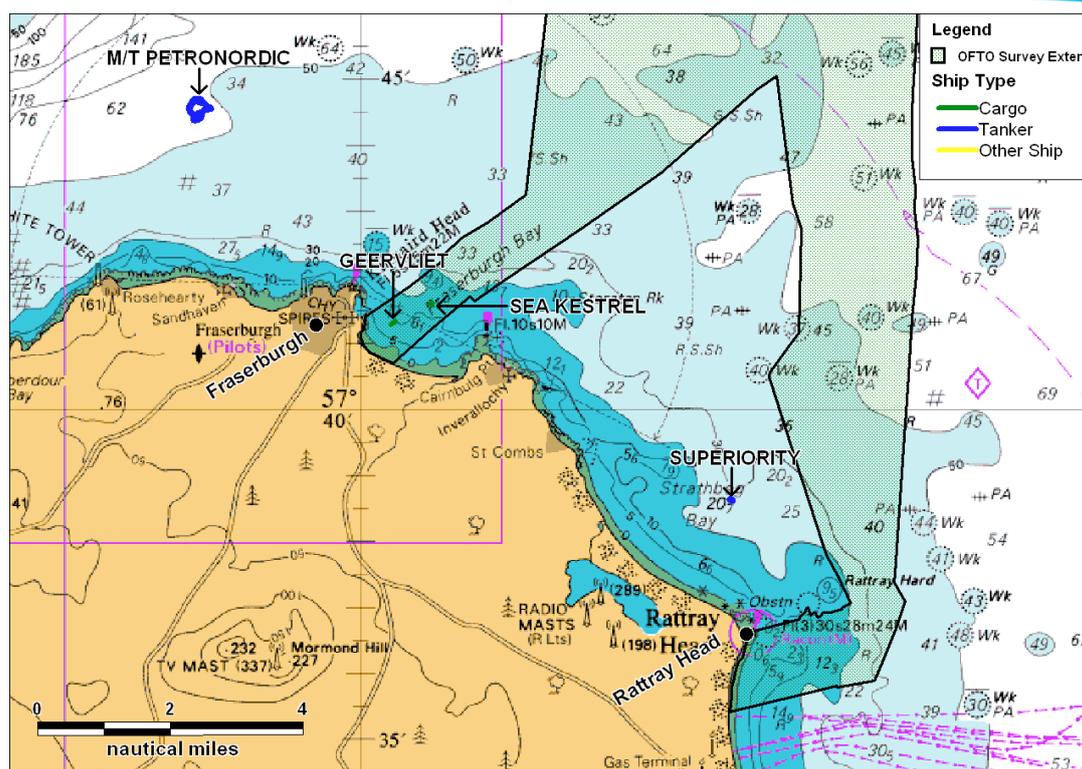
Figure 5.7 Detailed Fraserburgh and Rattray Head Anchored Vessels (84 days)

Within the Fraserburgh Bay cable route two cargo vessels were recorded at anchor during three days. The nearest anchored vessel to the Rattray Head cable route was a tanker located 1.5nm west of the cable anchored in Srathbeg Bay for one day in September 2011.

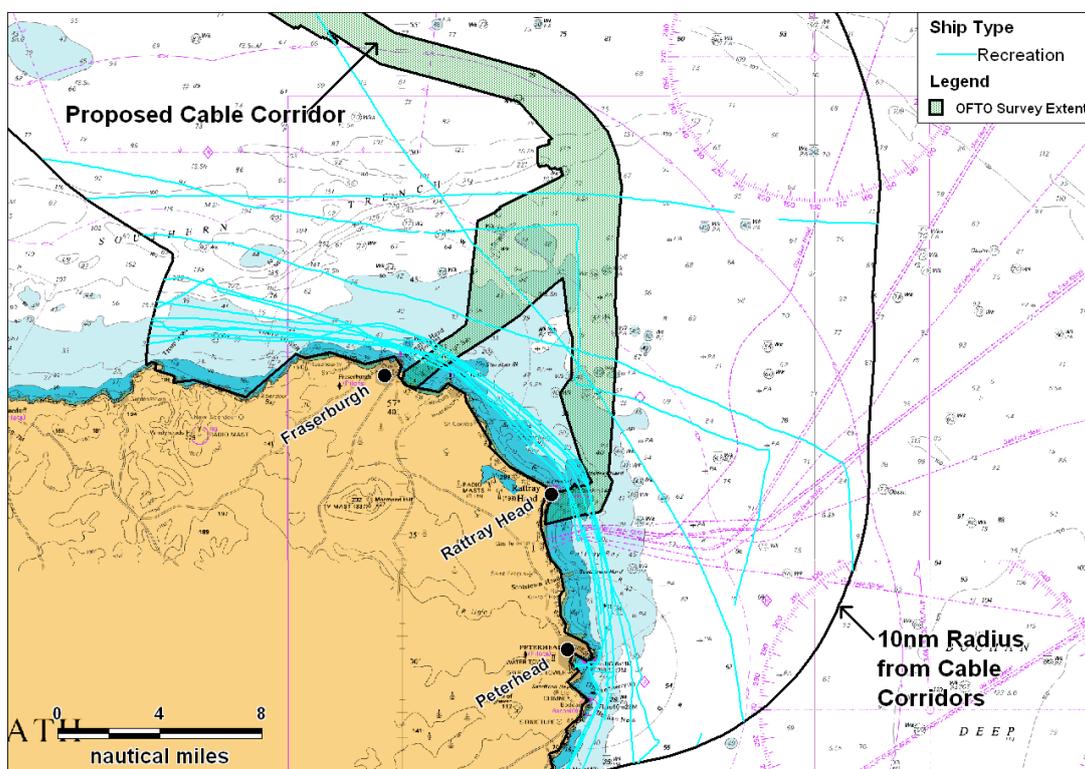
Figure 6.1 Recreation Vessels Recorded during Survey (28 days)

Figure 6.1 presents the AIS recreation vessel tracks recorded from the *Ivero* survey relative to the proposed cable route and landfall options.

On average there was just under one recreational vessel recorded during the survey within 10nm of the offshore export cable routes. The majority of vessels were recorded transiting along the Aberdeenshire and Banff/Buchan coastline (within 2nm of land) off Rattray Head, Fraserburgh and Rosehearty.

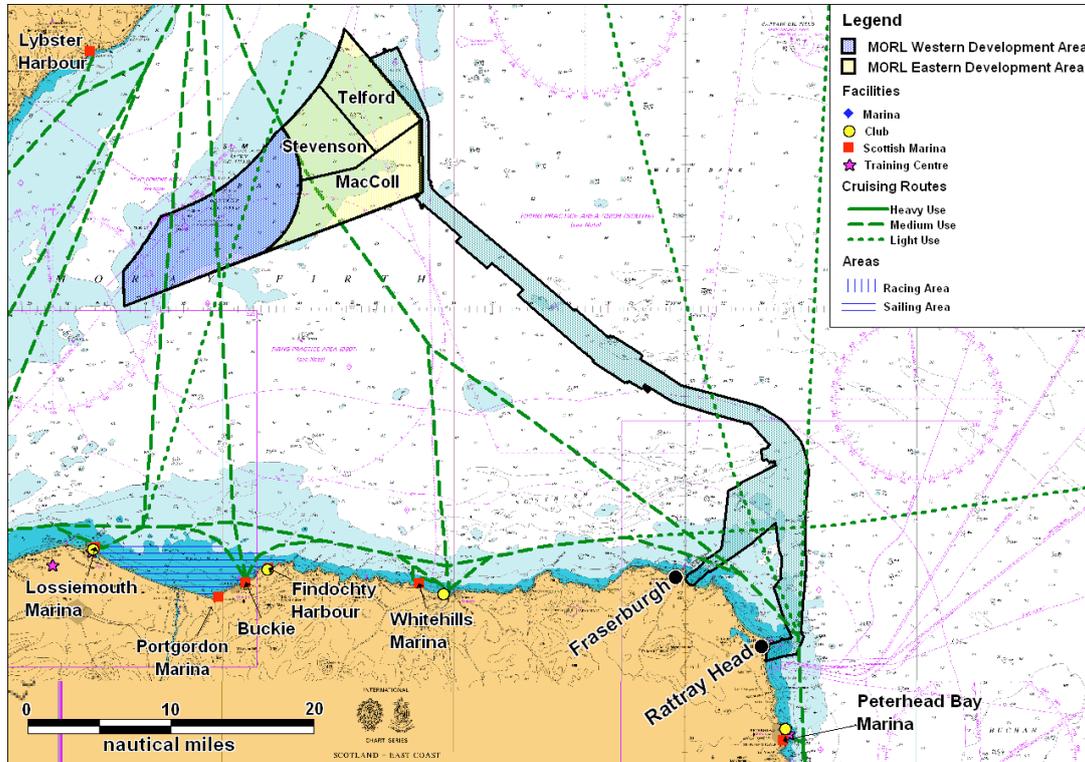
Figure 6.2 Recreational Information for the Moray Firth and Cable Route

A chart of the recreational sailing activity and facilities relative to the offshore export cable route is presented in Figure 6.2.

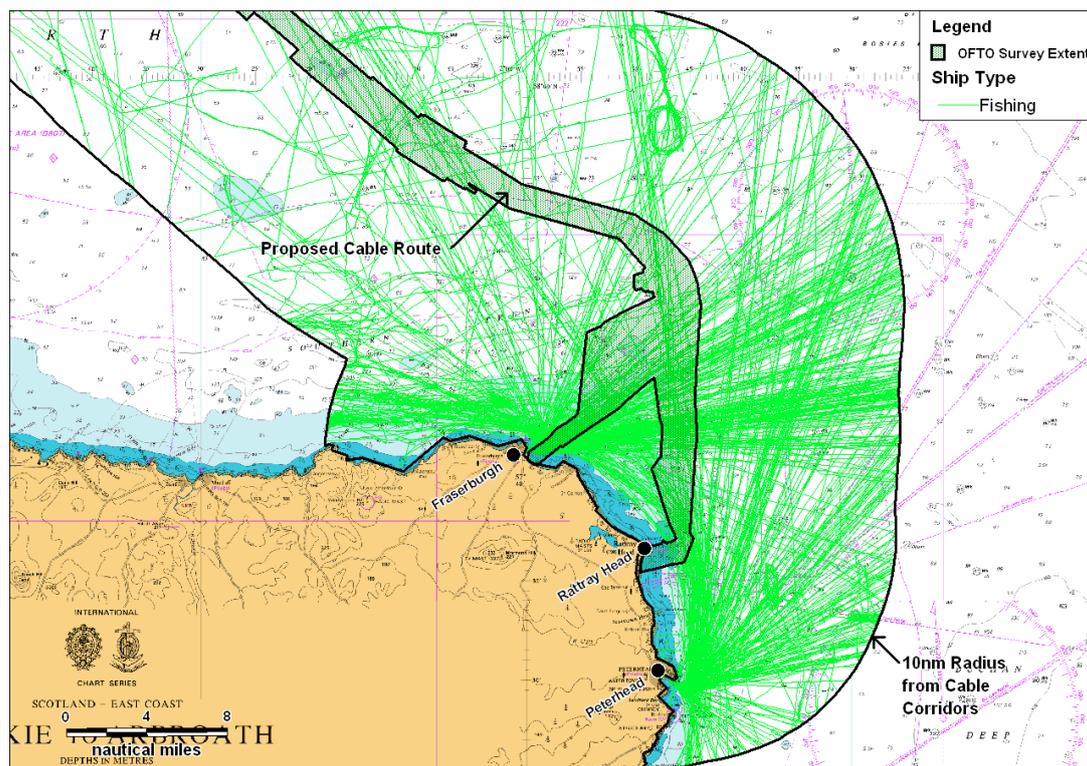
Figure 7.1 Fishing Vessels recorded During Survey (28 days)

The following chart presents the AIS fishing vessel tracks recorded from the *Ivero* survey relative to the cable route and landfall options.

On average there were 110 fishing vessels recorded during the survey within 10nm of the cable route. It can be observed that fishing vessel tracks were mostly recorded headed in/out of the fishing ports of Fraserburgh and Peterhead, where fish is landed for markets.

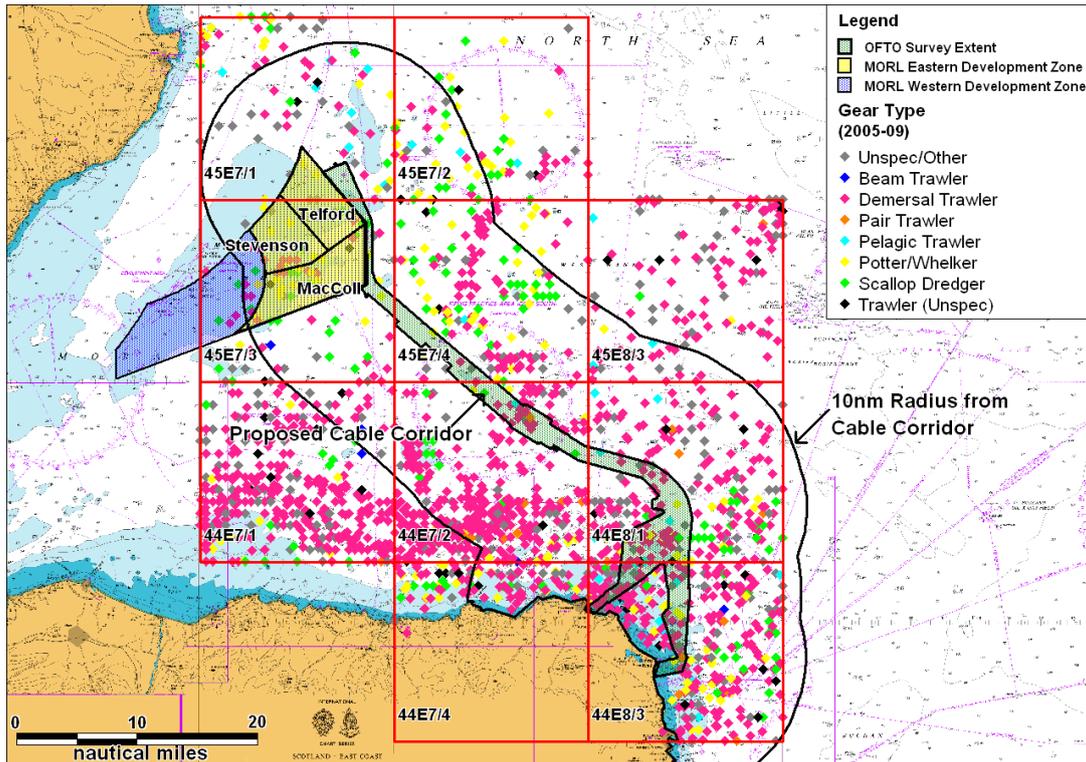
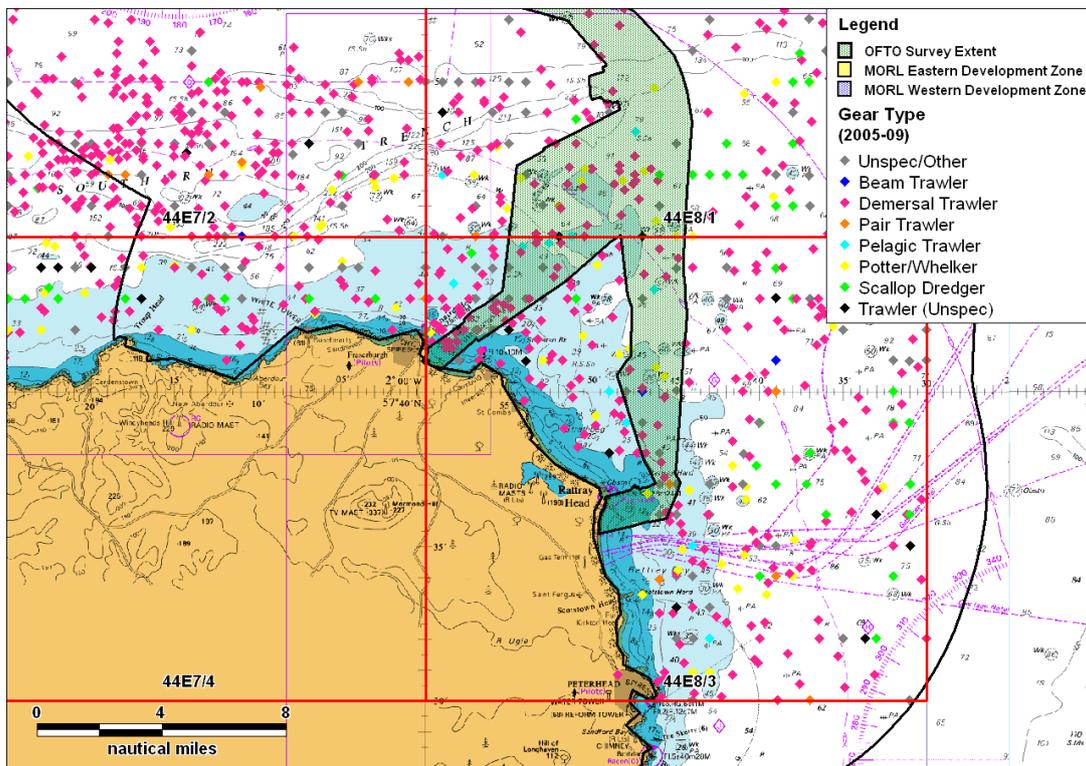
The fishing vessel sightings colour-coded by gear type are presented in overview and detailed plots in Figure 7.2 and Figure 7.3.

Figure 7.2 Overview Fishing vessels Gear Type

Figure 7.3 Detailed Fishing vessels Gear Type for Landfall Options

The main fishing method overall was demersal trawling, accounting for approximately 61% of all sightings with scallop dredgers and potters accounting for 16% of sightings. It is noted that 16% of sightings were unspecified.
