moray offshore renewables ltd

Environmental Statement

Technical Appendix 5.2 E - Navigational Risk Assessment (OfTI)

Telford, Stevenson, MacColl Wind Farms
and associated Transmission Infrastructure
Environmental Statement

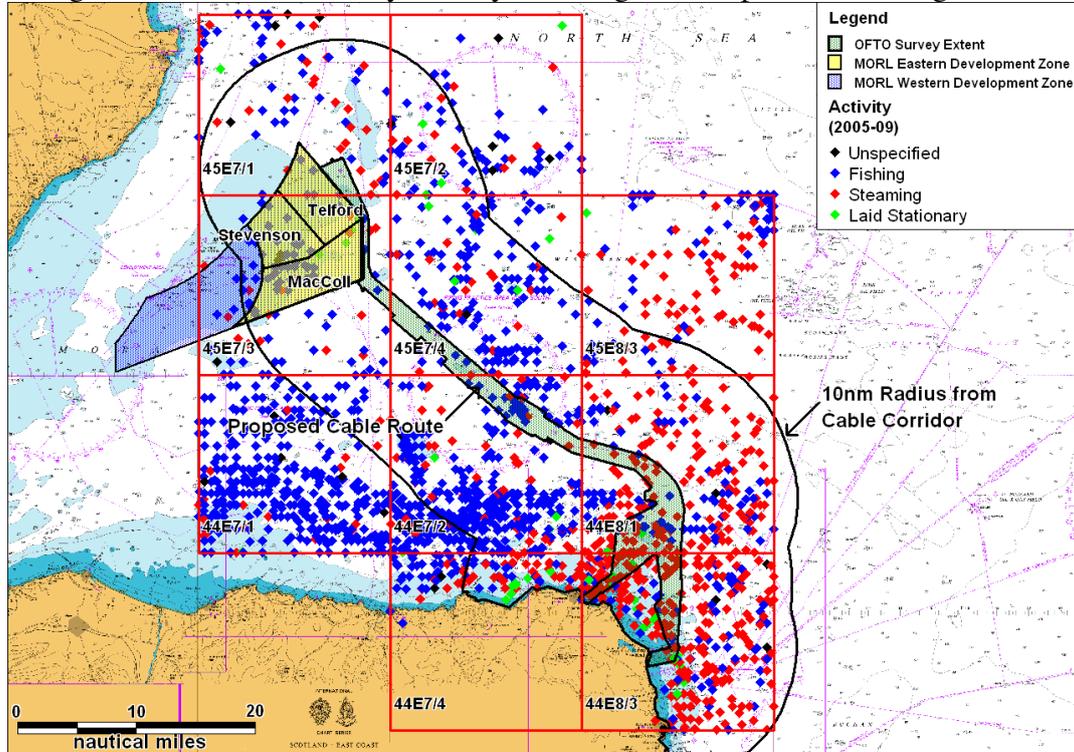
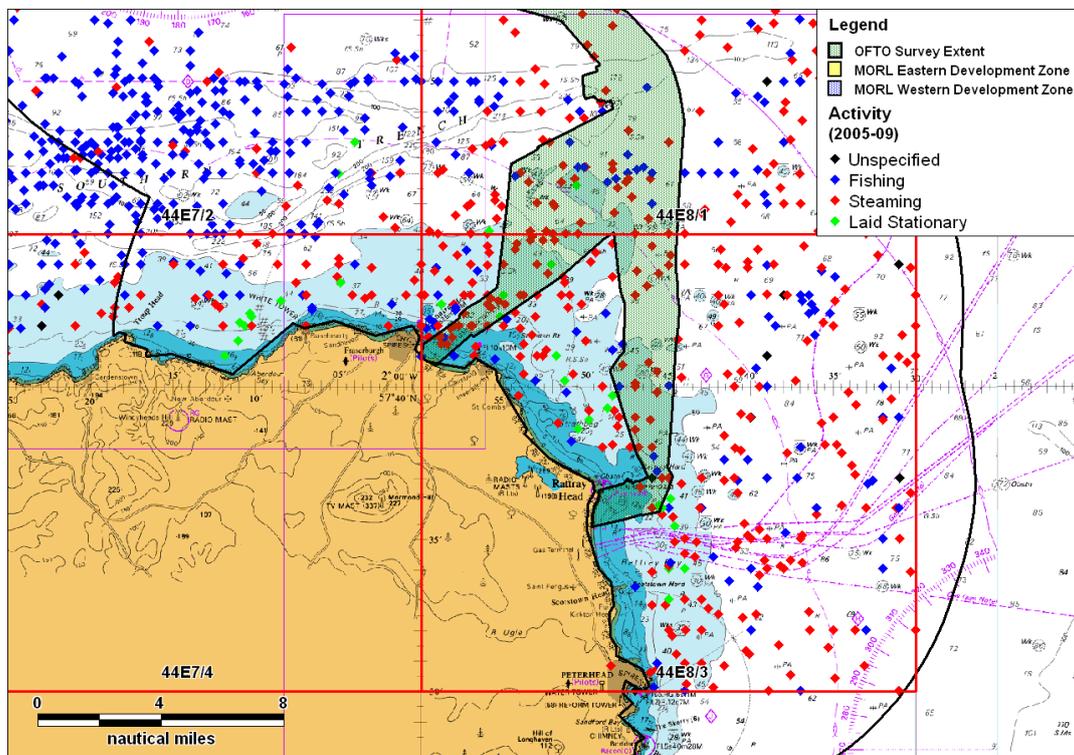
The fishing vessels colour-coded by activity when sighted are presented in Figure 7.4.

Figure 7.4 Overview Fishing vessels by Activity

Figure 7.5 Detailed Fishing vessels by Activity for Landfall Options

Excluding unspecified (2%), 65% of vessels sighted were engaged in fishing, i.e., gear deployed, 31% were steaming (transiting to/from fishing grounds to fishing ports including Peterhead and Fraserburgh) and 2% were laid stationary (vessels at anchor or pair vessels whose partner vessel is taking the catch whilst the other stands by).

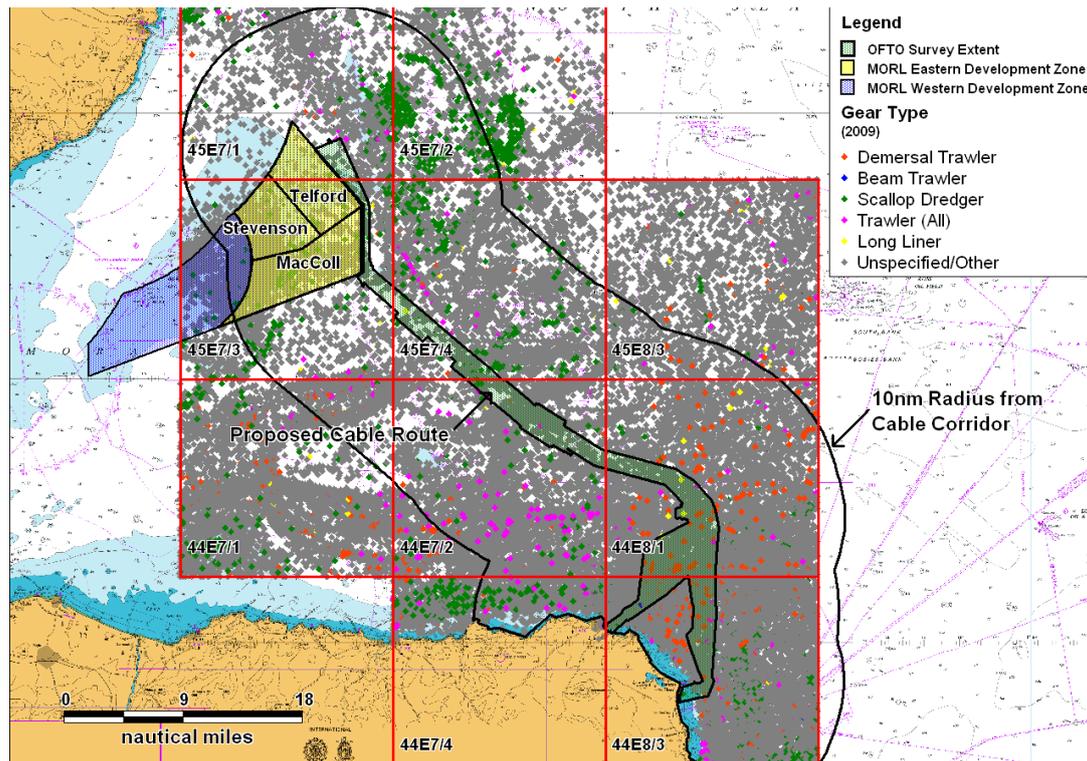
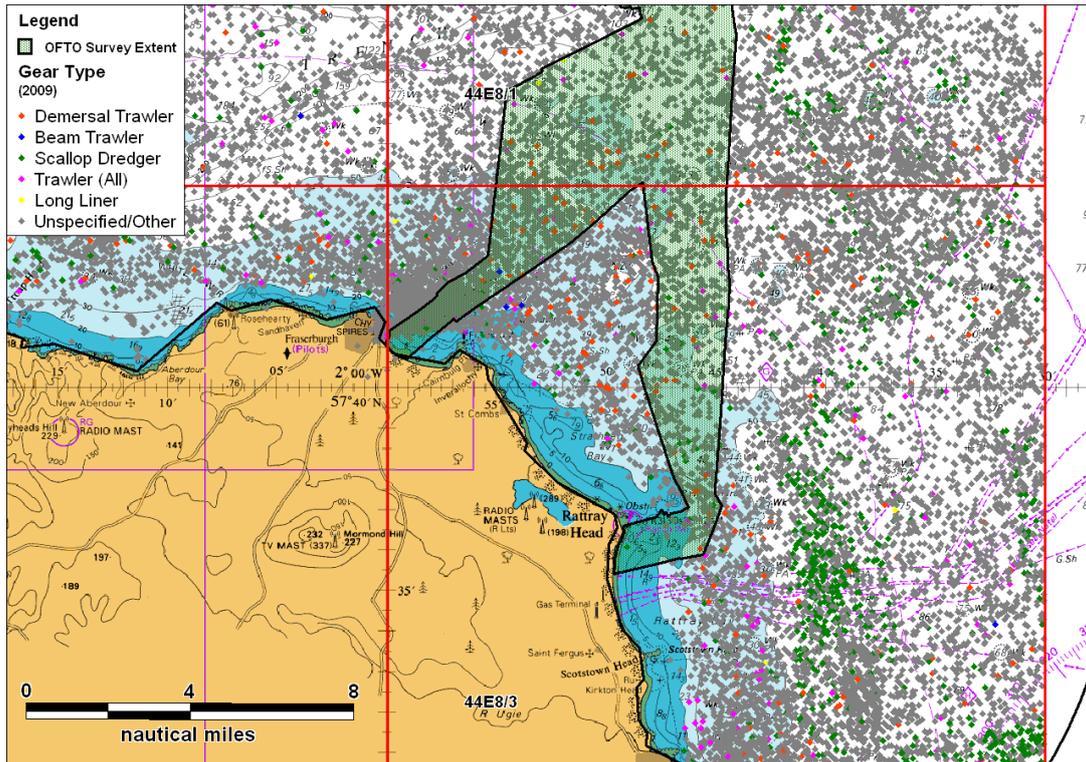
The fishing vessel satellite positions recorded in 2009, colour-coded by vessel type (where available), is presented in Figure 7.6.

Figure 7.6 Overview Chart of Fishing Vessel Positions by Type (2009)

Figure 7.7 Detailed Chart of Fishing Positions by Type (2009) for Landfall Options

Excluding unspecified (95%), the majority of vessels recorded by satellite tracking were demersal stern trawlers (2%) and scallop dredgers (1.5%), with the remaining vessels made up of other trawlers (pair/beam/side) and long liners.

From the satellite positions plot it can be seen that there are relatively higher density areas of fishing vessels recorded within the Fraserburgh Bay cable route, (i.e. within 4nm of port approaches). However it is noted the vast majority of vessel sighting speeds were over 6 knots (90%), and hence were likely to be on transit to/from port.

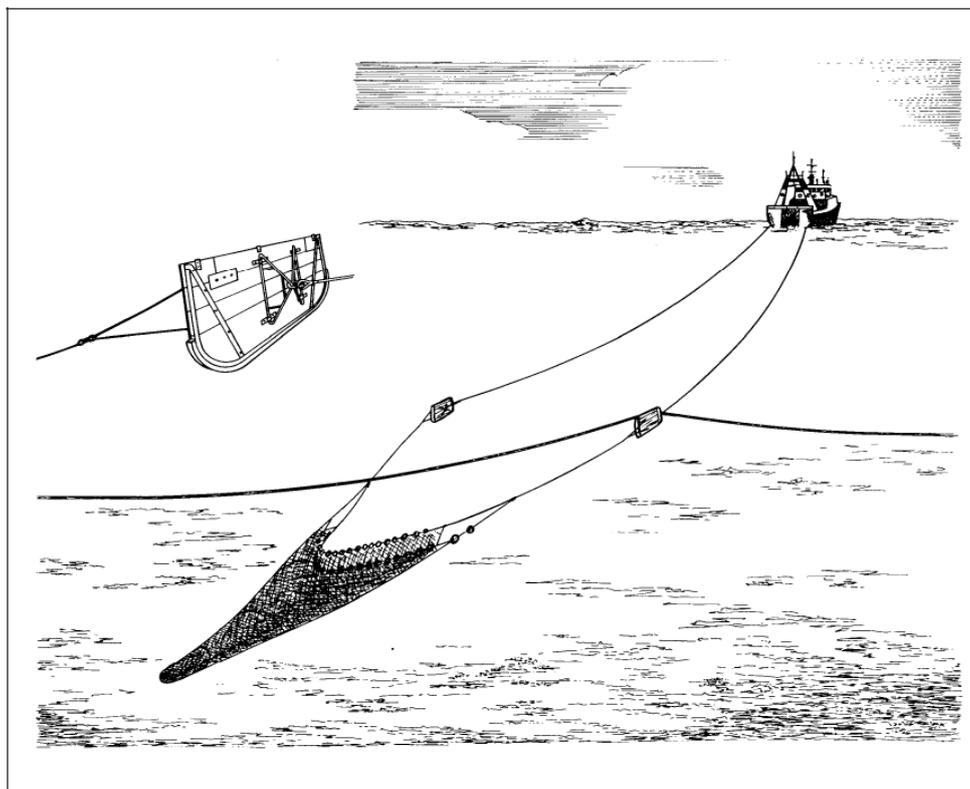
The gear consists of a net in the shape of a funnel attached to the vessel by wire ropes or 'warps'. As the net is towed over the sea floor the mouth is kept open by a combination of boards, floats and weights. The tail end of the net where the fish are trapped is the 'cod end'. Figure 8.1 presents a schematic of a typical Bottom (Otter) trawler.

Figure 8.1 Example of Bottom (Otter) Trawl Catching a Cable (Ref. iii)

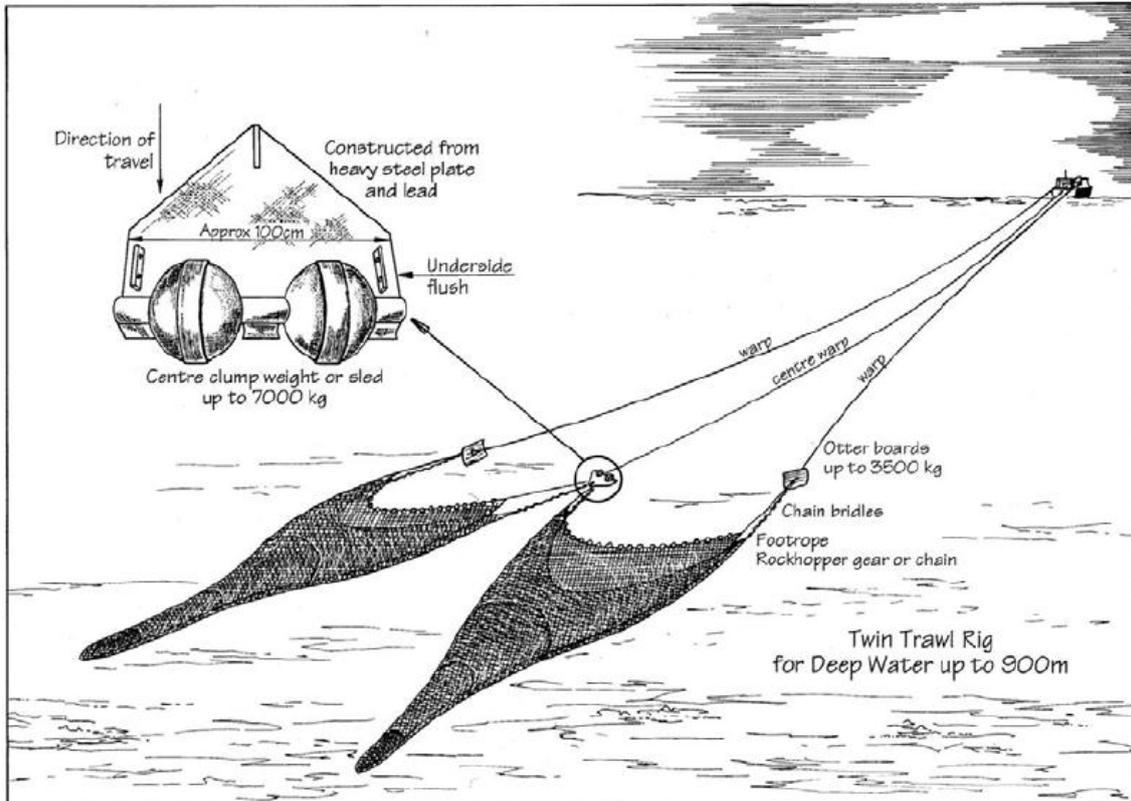
Figure 8.2 Twin Demersal Otter Trawl (Ref. iii)

The length of the warp is normally about three and a half to four times the depth of the water and can be used in depths of 100-450m from the stern of the vessel. Figure 8.2 presents a schematic of a Twin Demersal Otter trawler.

The main components of an Otter Trawl that have the potential to hook a subsea cable are the trawl doors and the clump weight.

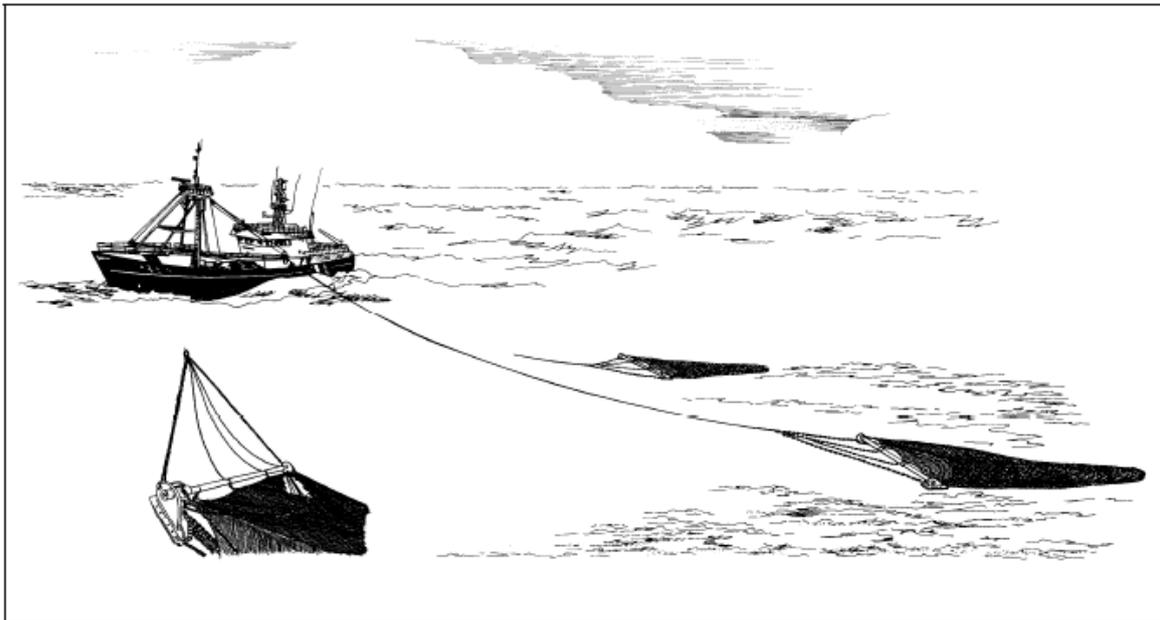
Figure 8.3 Beam Trawler (Ref. iii)

A schematic of a typical Beam trawler is present in Figure 8.3, below.

The main components of a Beam Trawl that have the potential to hook a pipeline are the beam and runners/shoes.

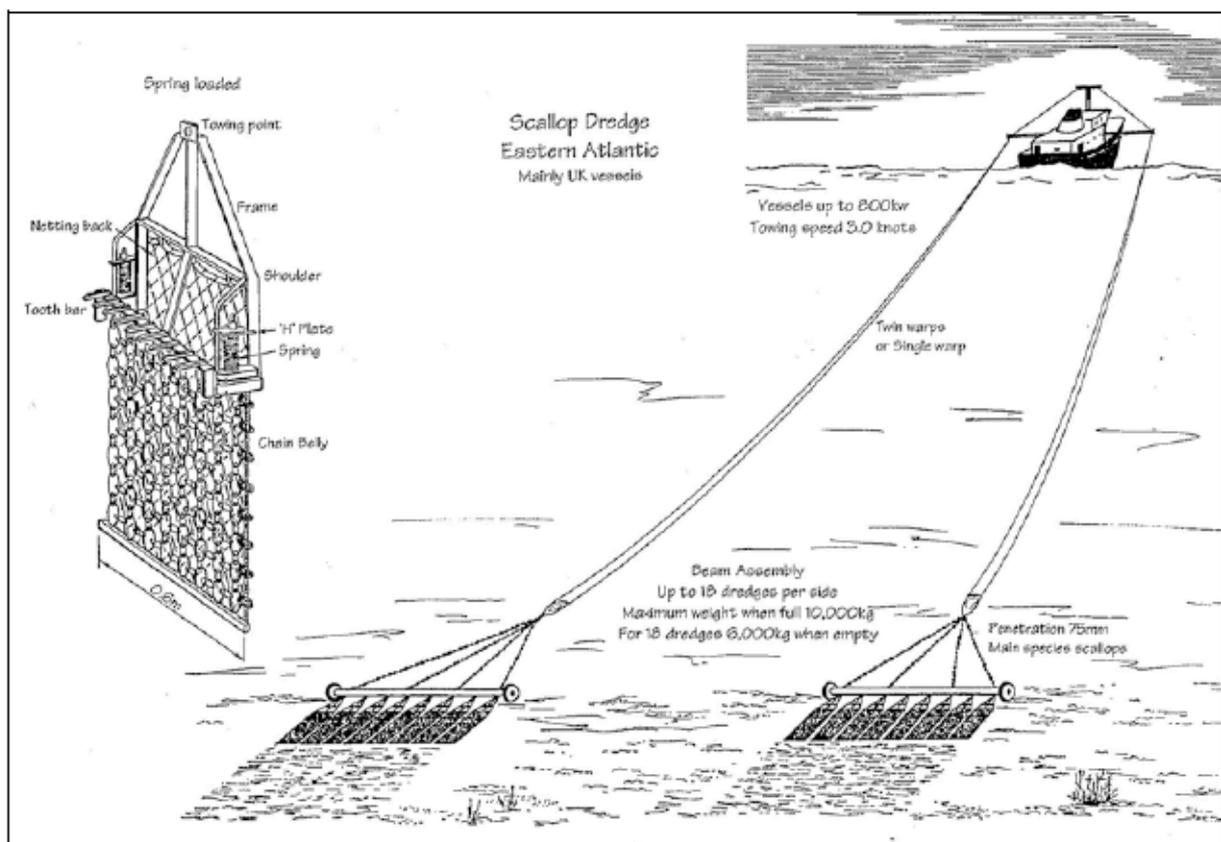
Figure 8.4 Plan View of Scallop Dredger (Ref. iii)

Most Scallop Dredgers have a chain bag which drags along the bottom collecting the catch. Some also use steel teeth which penetrate the seabed for a few centimeters. Like other gear types, greater bottom penetration can occur under unusual conditions, such as when a dredge pushes a rock ahead of it.

A dredge 4.5m wide with tickler chains can weigh in excess of 2,200kg when empty. With towing speeds ranging up to five knots, this type of gear can easily damage a submarine cable. In some fisheries, deflecting bars and wheels have been added to help the gear pass over seabed obstacles. Such devices may also help prevent entanglement with cables.

An example of a typical Scallop Dredger is presented in Figure 8.4.
